HAJI KHAN: A MEDIAN TEMPLE IN HAMADAN PROVINCE, IRAN

Abstract: The Haji Khan archaeological sites are located within the precinct of the Ibn Sina Petrochemical Company in the province of Hamadan, western Iran. A single season of excavations directed by Esmail Hemati Azandaryani was undertaken in 2017 and led to the discovery of a temple dating to the Median period. This temple, with its stepped lozenge plan, is very similar to, but larger than the Central Temple at Tepe Nush-i Jan near Malayer.

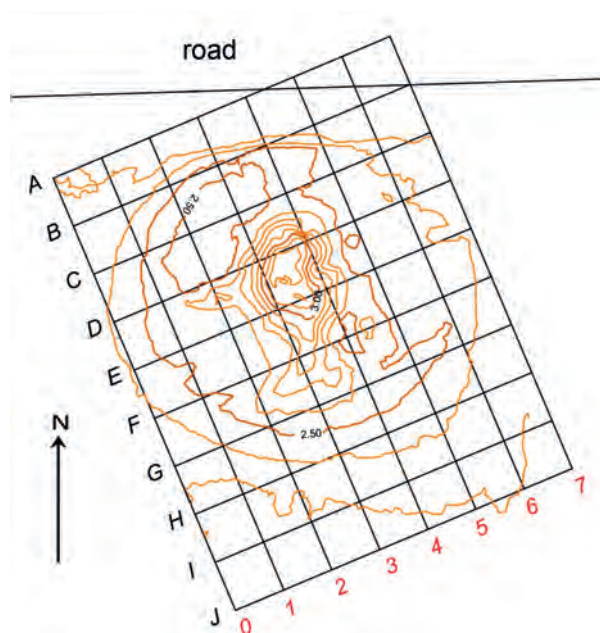
Fig. 8. Topographic plan of Haji Khan Tappeh. The contour lines are measured from an arbitrary level about 1610 m above sea level.

centre of the circular enclosure, where a building measuring about 25 m from north to south and about 20 m from east to west was discovered. The top of this mound is about 4 meters above the surrounding plain (Fig. 8).

The excavation was initially carried out within 10×10 m squares named after the edges of the square: thus the square at the north corner of the grid is Square AB67 (Fig. 8). The first trench excavated, GH34, measuring 5×10 m, contained no traces of architectural or other features (Fig. 12). However, pottery fragments dated to Iron Age III (corresponding to the Median period) were recovered. After reaching natural clay mixed with gravel (Fig. 13), the excavations were shifted to the elevated part of the tappeh.

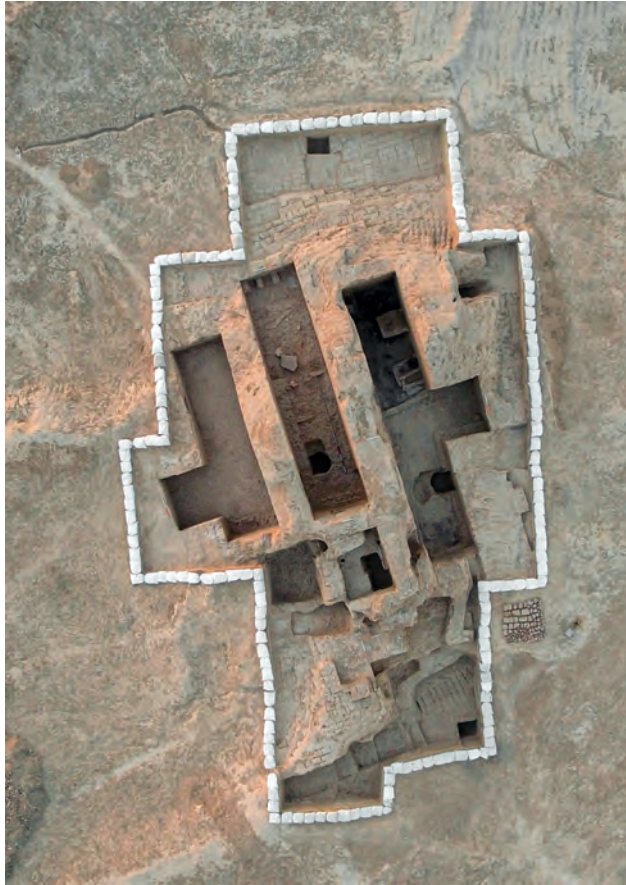
Fig. 14. Detailed air view of the excavations.

Site A of Haji Khan consisted of a temple with a stepped lozenge shaped plan, consisting of six rooms of various sizes (Figs. 14-16 and 18). The easternmost room, Room 1, is the largest room of the building: it has a rectangular bay on the east side and next to the east wall of the northern part of the room was a stepped altar on which fire had been burnt. A doorway

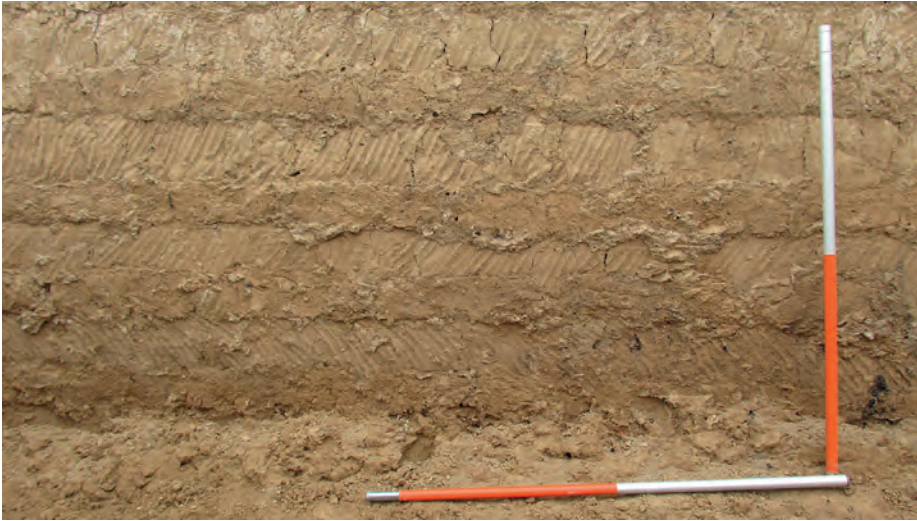
Fig. 17. Detail of the east wall of Room 2, showing alternate rows of diagonally impressed finger marks.

No foundations for the walls were identified. The bricks were laid so that their surface was similar to the effect of horizontal feather edge (overlap) fence panels (Figs. 17, 26 and 48). The surfaces of the walls were coated with one layer, and in some cases two layers, of white plaster, on which the diagonal imprints of fingers can be seen, sometimes in a herring bone pattern (Fig. 17). A similar surface treatment to the walls was observed at Tepe Nush-i Jan (Stronach & Roaf 2007: pl. 42c) and Tell Ozbaki (Madjidzadeh 1389/2010: fig. 308).

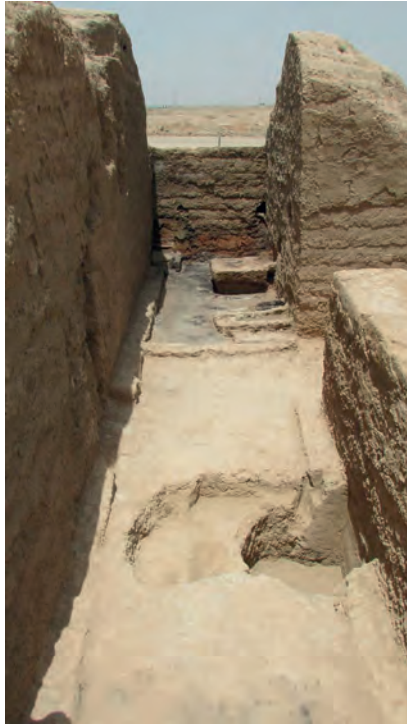
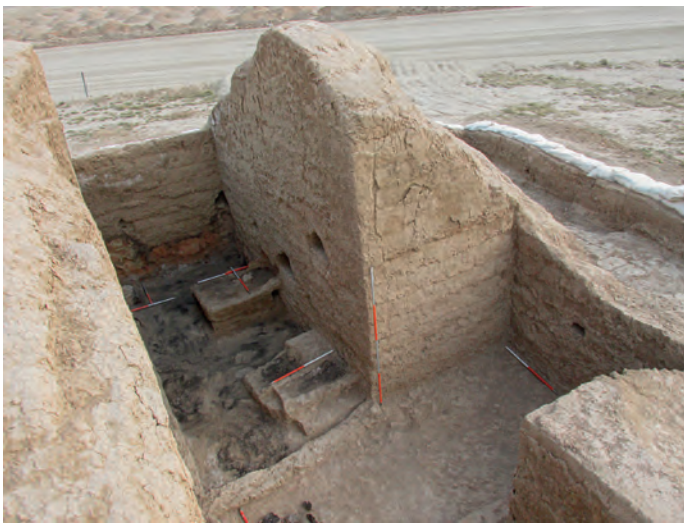
Fig. 19. View of Room 1 looking north.

Fig. 20. Room 1 from the SW, showing the north end and the east bay.

Room 1 is in the eastern part of the building (Figs. 19-20). It is about 13.67 m long and approximately 2.60 m wide, being wider at the north end than at the south, with a rectangular bay in the centre of the east wall measuring 265 cm wide (north-south) and 230 cm deep (east-west) (Fig. 20). The maximum preserved height of the walls is 480 cm.

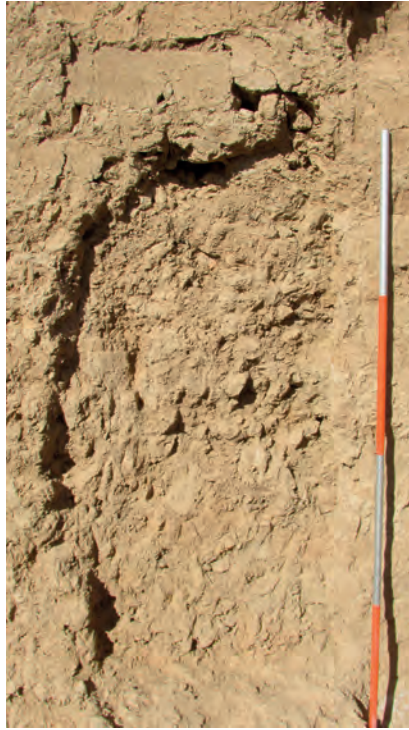
Fig. 21. The door from Room 1 to Room 2.

To the south of the east bay, there is an entrance in the west wall leading to Room 2 (Fig. 21). It is 100 cm wide and 156 cm high. The soffit of the doorway was a semi-circular arch³. This doorway and the doorway from Room 2 to Room 3 are similar to the doorways in other Median sites such as Nush-i Jan (Stronach & Roaf 2007: 184-185), Godin (Gopnik 2011:

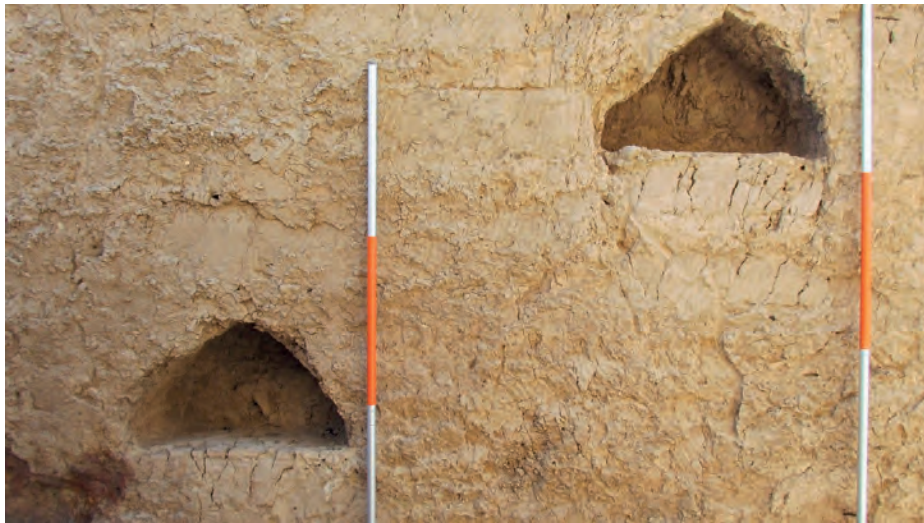
Fig. 22. Niches on the east wall of Room 1.

There were several niches in the walls of Room 1. Three were in the northern part of the east wall (Fig. 33). The northernmost was in the north-east corner of the room and was apparently oriented at an angle to the walls. It was 42 cm wide, 41 cm high and 30 cm deep and 115 cm above the floor. The other two niches further south on the east wall were 65-70 cm wide, 35-40 cm high, and 30 cm deep (Fig. 22). The northern niche was 85 cm above the floor and the southern was 155 cm above the floor. The upper parts of these niches were constructed of two bricks leaning against each other. Through the application of mud plaster the form of these niches was converted into a low pointed arch.

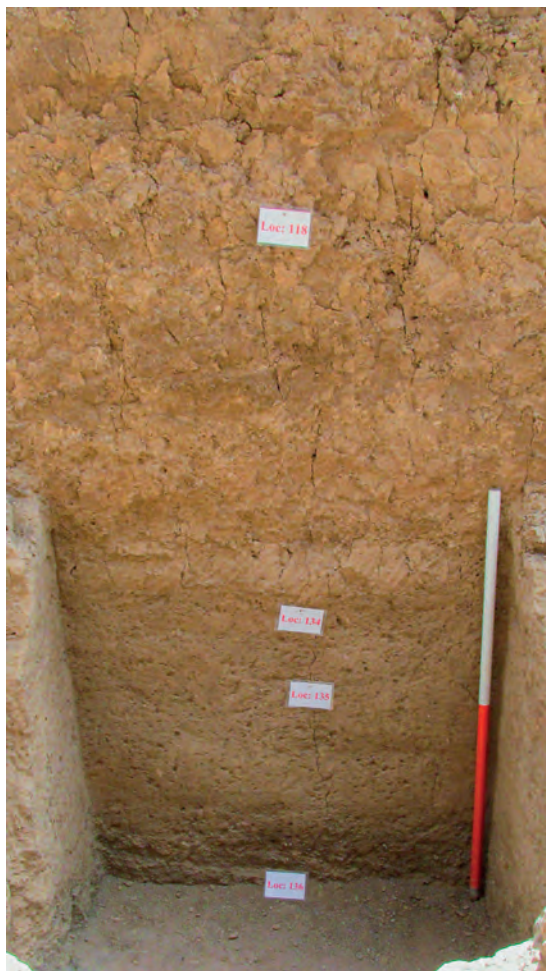
Fig. 23. Sondage through the floor of Room 1 next to the east wall in the southern part of the room.

A sondage through the floor of Room 1 showed that the floor was 4-6 cm thick and made of clay with some plant temper. Its surface was white plaster (Fig. 23). In places four layers of flooring were recognised.

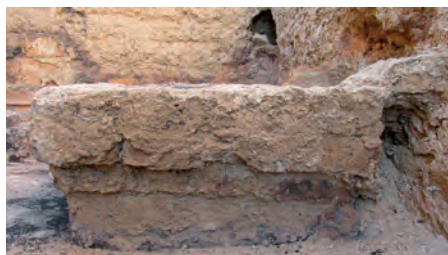
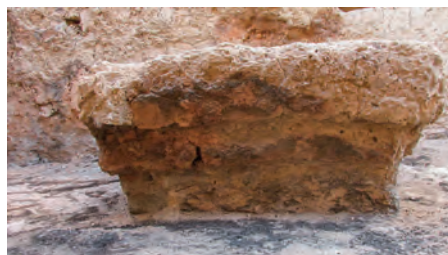
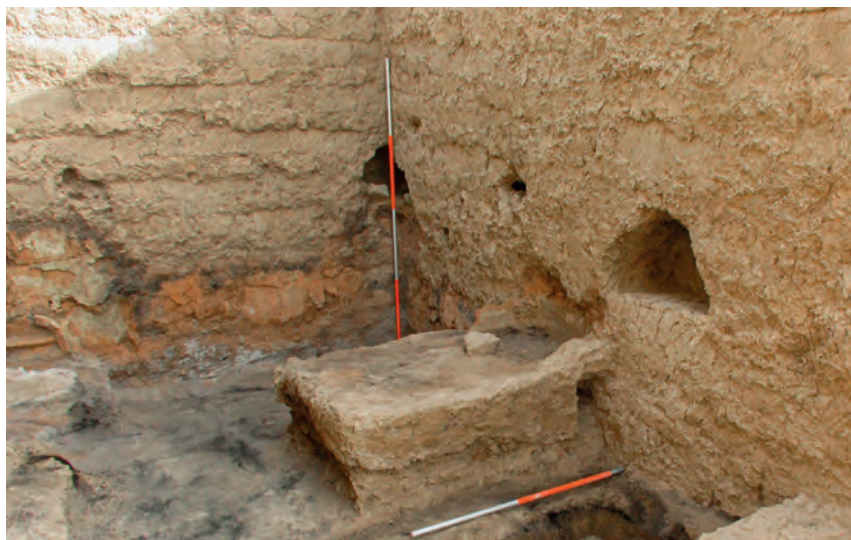
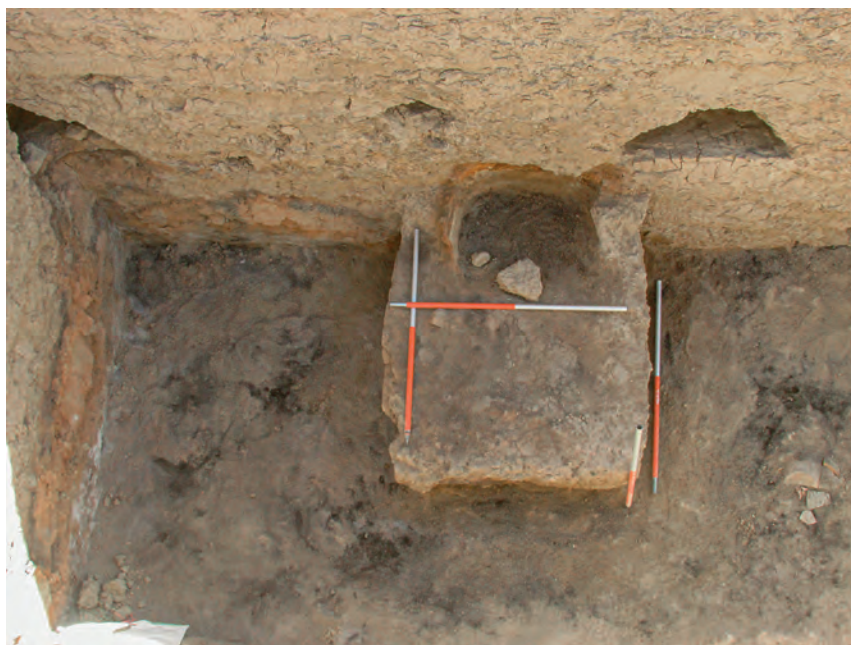
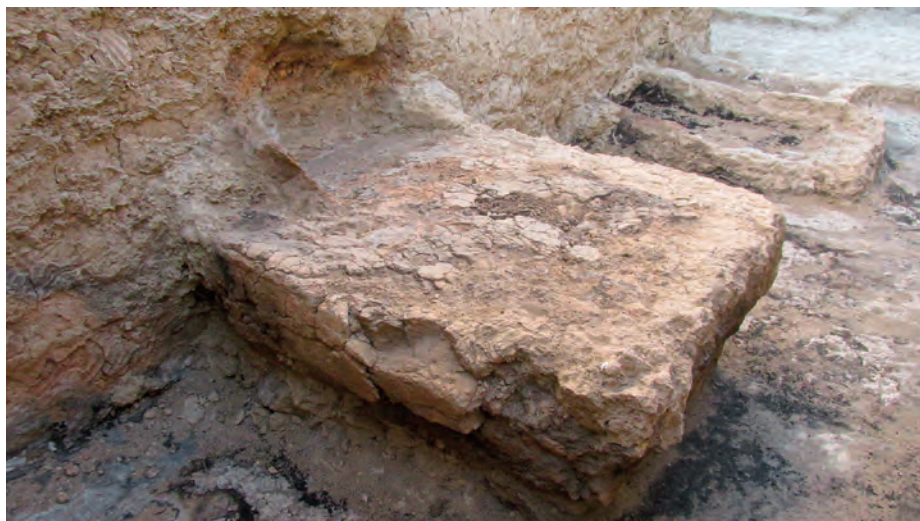
Fig. 24. The altar from the south.

Fig. 25. The altar from the west.

Fig. 26. The north-east corner of Room 1 showing the altar, a niche in the corner behind the ranging rod, a niche in the east wall and two possible ventilation holes at the same height as the niches on the north and east walls.

Fig. 27. View of the altar from the west, showing how the secondary fireplace was dug into the face of the east wall.

Fig. 28. The altar from the north-west.

A square mud-brick structure was erected 145 cm from the north wall and 15 cm from the east wall in the north part of the room (Figs. 24-28). This structure is similar to the altar in the Central Temple at Nush-i Jan (Stronach & Roaf 2007: 82-85, fig. 2.13 and pls. 17-19), with projecting ledges getting wider at the top. The Haji Khan altar is square and has two projecting ledges (Figs. 24-28). The lower part of the altar measured 90 × 90 cm and was 24 cm high. The second step measured 100 × 100 cm and 12 cm high, and the top step measured 110 × 110 cm and 24 cm high. All are made of mud bricks measuring 45 × 25 × 12 cm. The shaft consists

At a later date the altar was modified so that it was no longer free-standing but was attached to the east wall of the room. The top surface of the altar was extended to the east to connect with the east wall and the east wall was cut back to a depth of about 10 cm in order to create an oval fireplace (Figs. 26-28).

Traces of burning extended to a height of c. 40 cm on the back wall. Narrow retaining side walls, between 7 and 10 cm thick, were constructed at the north and south next to the east wall. They were preserved to a height of less than 20 cm. The fireplace was oval, made of clay with vegetal temper, which had become red due to heat. Its interior dimensions were at most 55 × 65 cm, and its external dimensions were 77 × 62 cm. The interior surface was pale and had turned grey because of the heat. The western edge of this fire installation was not preserved but it seems that this fire installation was originally an oval oven extending halfway across the altar.

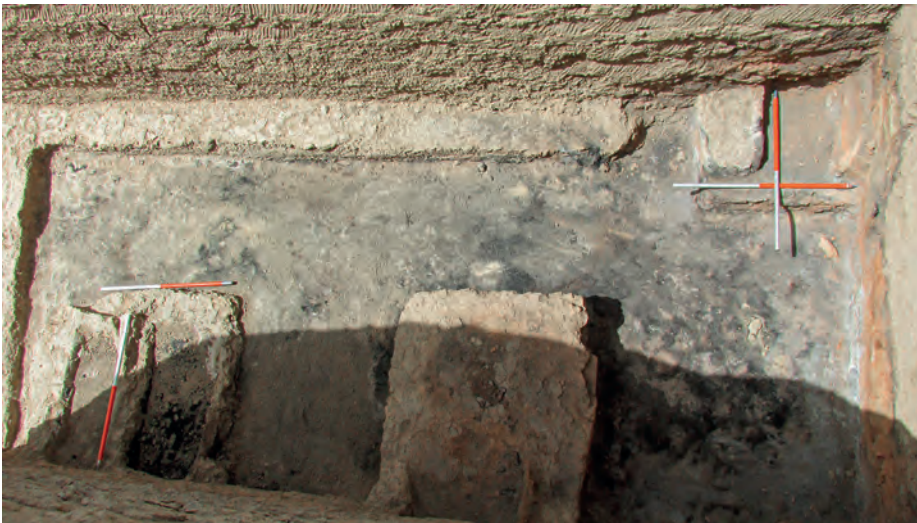
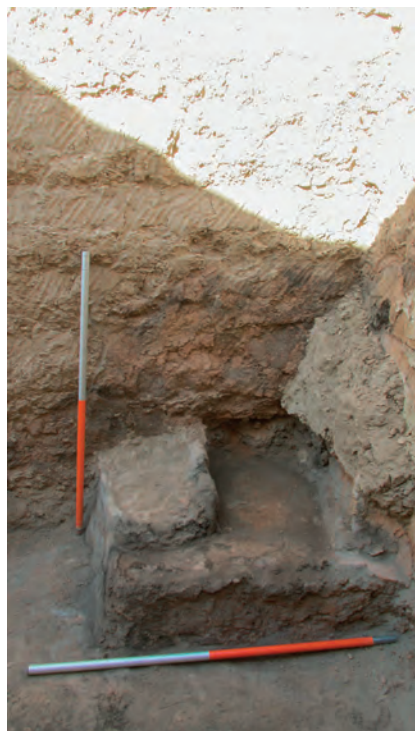
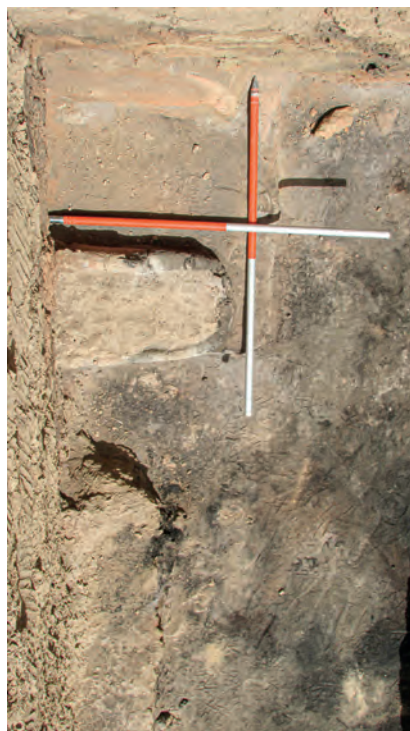
Fig. 29. Vertical view of the north end of Room 1 showing the altar against the east wall and fire installations in the north-west corner and against the east wall to the south of the altar.

Fig. 30. The fire installation in the north-west corner of Room 1.

Fig. 31. The fire installation in the north-west corner of Room 1 from above.

A further fire installation was constructed in the north-west corner of Room 1 (Figs. 29-31). This consisted of a rectangular mud-brick platform measuring (85 cm wide (N-S), 65 cm deep (E-W), and 27 cm high). It was divided into two parts. To the north in the corner was a fireplace level with the top of the platform (about 55 cm long (E-W), 35 cm wide (N-S), and 9 cm deep). The oval shape of this fireplace was formed by mud plaster. To the south raised up about 9 cm above the top of the platform was a U-shaped fireplace surrounded on three sides by a narrow ledge about 4-6 cm wide. The northern fireplace may have been replaced by a later fireplace level with the top of the southern fireplace. All surfaces of the platform and the fireplaces were burnt. The west wall behind this platform was also burnt to a grey colour. The north wall behind the platform and extending to the east the north wall was burnt grey and red in a semi-circular shape edged in black from the smoke of the fire (Fig. 32). Further to the east the lower part of the north wall was also burnt to a red colour again with a black edge.

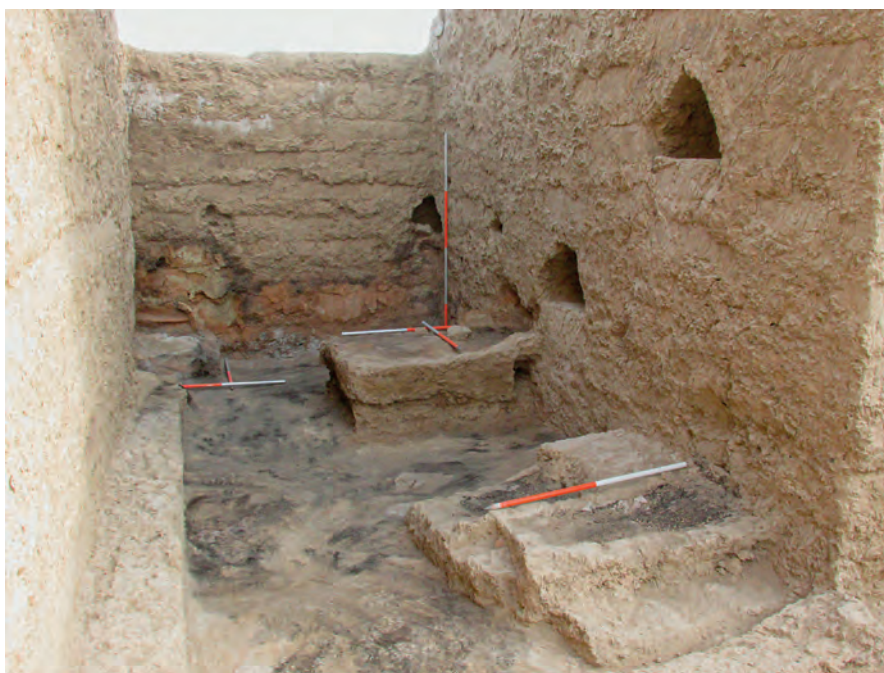
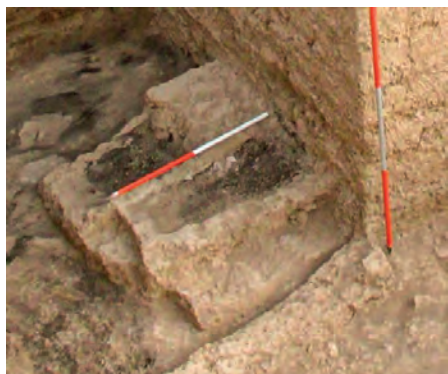
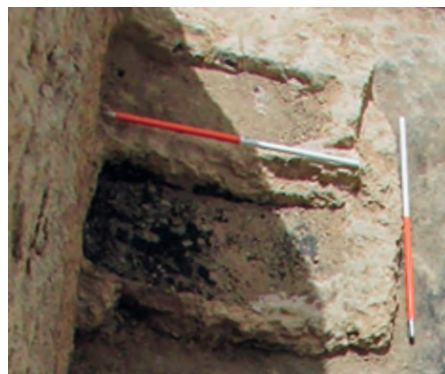
Fig. 33. The north end of Room 1 with the fire installation south of the altar in the foreground.

Fig. 34. The fire installation south of the altar in Room 1.

Fig. 35. The fire installation with the northern fire bowl fully excavated.

South of the altar, next to the east wall of Room 1, was a roughly square platform measuring c. 124 cm by 144 cm N-S and c. 60 cm high. On this platform, fire installations were constructed (Figs. 33-35). As in the case of the fire installation in the north-west corner of Room 1, there seem to have been two phases of construction⁵. The earlier phase included a fireplace, whose northern edge coincided with that of the platform and whose internal dimensions were 103 cm long, at least 54 cm wide, and 15 cm deep (the external dimensions were 124 cm long, at least 66 cm wide, and 30 cm deep). In the later phase the lower fireplace was filled in and the surface of the platform was raised and a second fireplace replaced the earlier one located to the south. The internal dimensions of this later fireplace were 83 cm long, 40 cm wide, and 15 cm deep (the external dimensions were 110 cm long, 60 cm wide, and 30 cm deep). A considerable amount of grain, partly charred, was found in this installation.

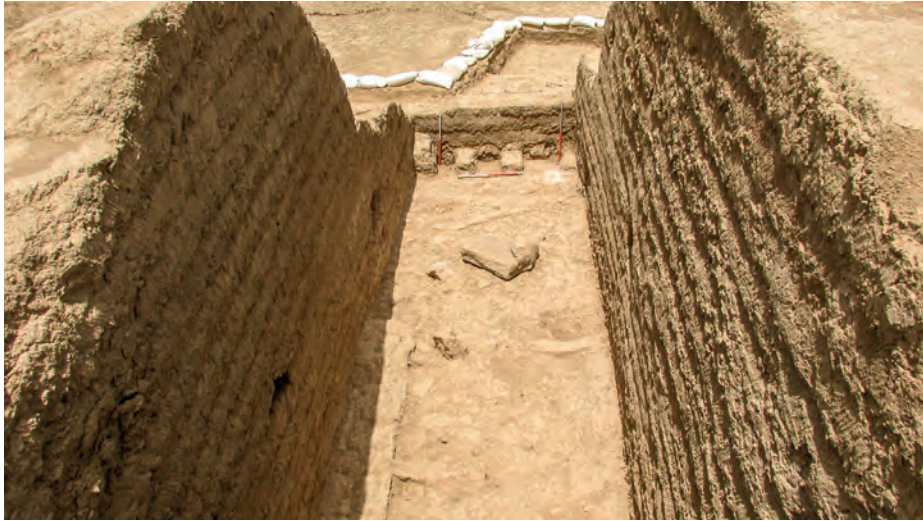
Fig. 36. View of Room 2 looking north. Note the bench by the west wall appears to continue further north than on the plan.

Room 2 is situated on the central north-south axis of the building. It is 11.81 m long and 2.60 m wide; the maximum height of the remaining walls is 4.8 m (Figs. 36 and 39). The northern wall of this room extends about 1.5 m beyond the north wall of Room 1 and about 2.2 m beyond the north wall of Room 3. This latter extension is comparable to the size of the rectangular bays in Rooms 1 and 3.

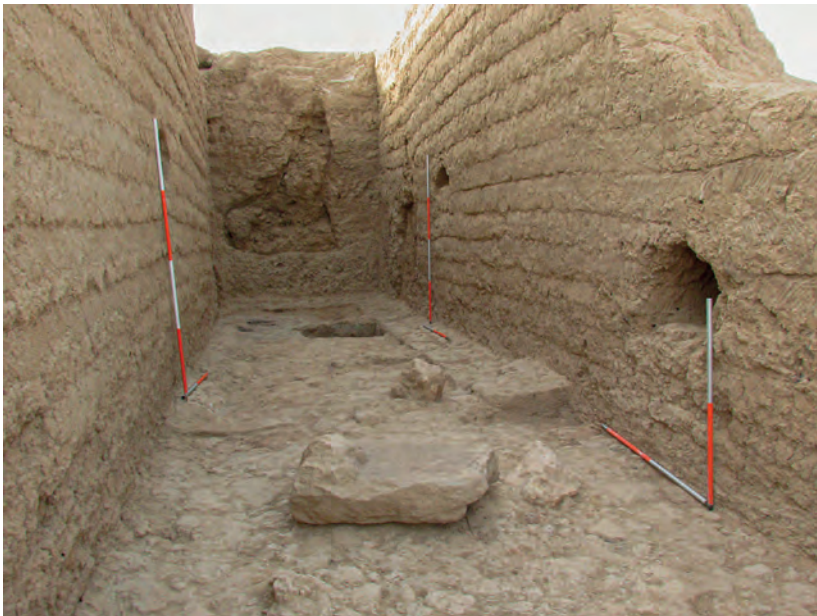
Fig. 39. View of Room 2 looking south.

It is very probable that there was a doorway in the south wall leading into Room 4, but the brickwork was not well-preserved and it was not possible to excavate the doorway without endangering the structural stability of the wall. The right hand (western) jamb of this doorway, however, appears to be visible in Figs. 38-39.

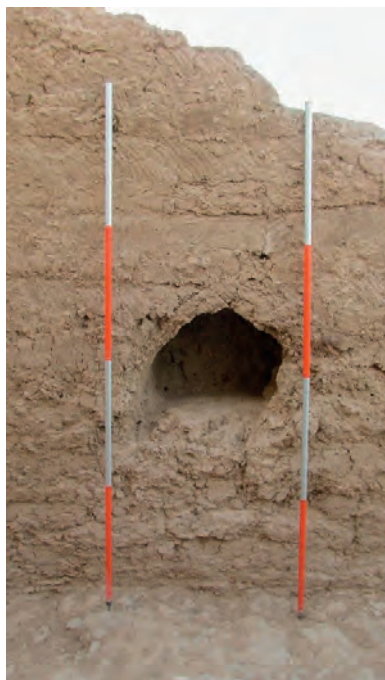
Fig. 40. The north niche in the west wall of Room 2.

There were two niches on the west wall. The northern niche was 70 cm wide, 50 cm high, and 50 cm deep. It was 87 cm above the floor of Room 2 (Fig. 40). The southern niche was close to the door leading into Room 3. It was 60 cm wide 30 cm deep, and originally 24 cm high (Fig. 41). At a later date two bricks of the standard size were inserted into the base of this niche.

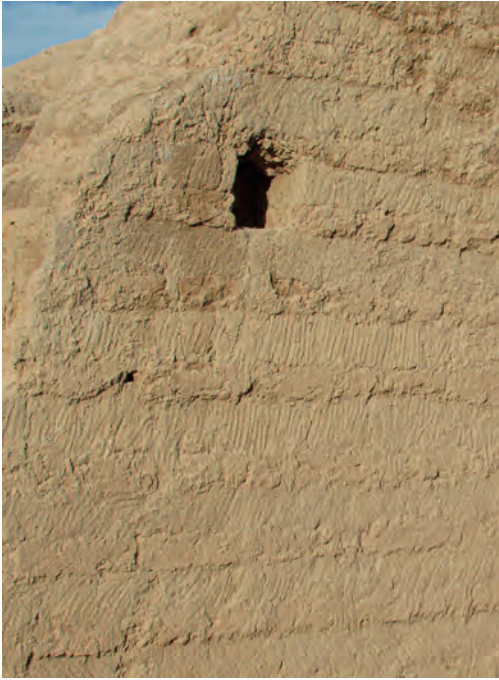
Fig. 42. The small northern niche high up on the east wall of Room 2.

There were also two niches in the east wall. The northern one was 20 cm wide, 20 cm high and 20 cm deep and was high up on the wall 265 cm above the floor (Fig. 42). Since it is small and high above the floor, it is possible that this hole had been used to hold a wooden beam. The corresponding part of the west wall where the other end of a beam would have been inserted was not preserved. The southern niche had a pointed arch profile and was 60 cm wide, 30 cm high, and 24 cm deep and was lower but still high up on the wall 165 cm above the floor (Fig. 43).

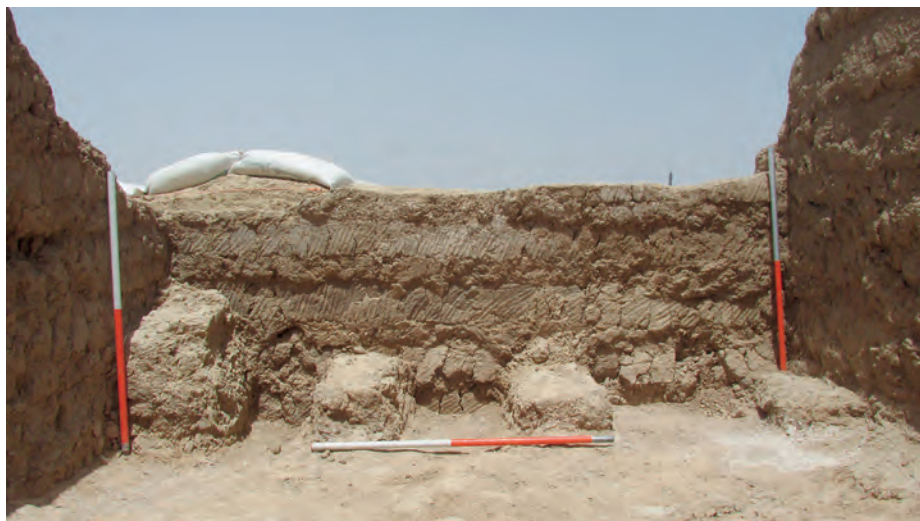
Fig. 44. Mud-brick structure against the north wall of Room 2.

A mud-brick feature was placed against the north wall (Fig. 44). This consisted of three courses of mud-bricks on top of each other in the north-west corner, a gap followed by two courses of brick, a second gap followed by a single brick, and a third gap followed by a single brick in the north-east corner. This feature was not well preserved and the edges of the different part were not always well defined. The excavators thought that two different sizes of bricks were used ($48 \times 30 \times 12$ and $45 \times 25 \times 12$ for the brick in the NE corner), but there was some difficulty in measuring the bricks because of the damaged state of the feature. The smaller brick size might have been due to this. These bricks were placed directly on the floor of the room. This feature is similar to the bench and rectangular bin built against the east wall of the antechamber (Room 2A) in the Central Temple at Tepe Nush-i Jan (Stronach & Roaf 2007: 76-77, figs. 2.2 and 2.4, and pl. 10c) and it is possible that originally the bricks in Room 2 of the Haji Khan temple were the supports for such a bench, but they are

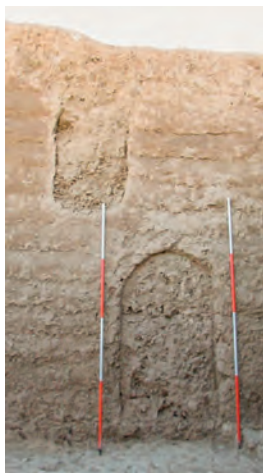
Fig. 45. The doorway from Room 3 to Room 2.

The arched doorway leading into Room 2 was located towards the southern end of the east wall (Fig. 45).

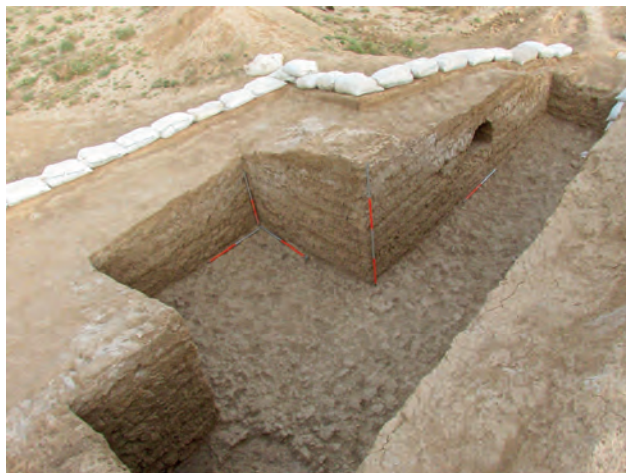
Fig. 46. View of Room 3 from the south-east.

To the west of and parallel to Rooms 1 and 2 was Room 3 (Fig. 46). It was 9.54 m long and 2.55 m wide. Matching the east bay in Room 1, Room 3 had a rectangular bay in the west wall. This was 2.65 m wide (N-S) and 2.30 m deep (E-W). The bays in Rooms 1 and 2 lie on the central east-west axis of the building.

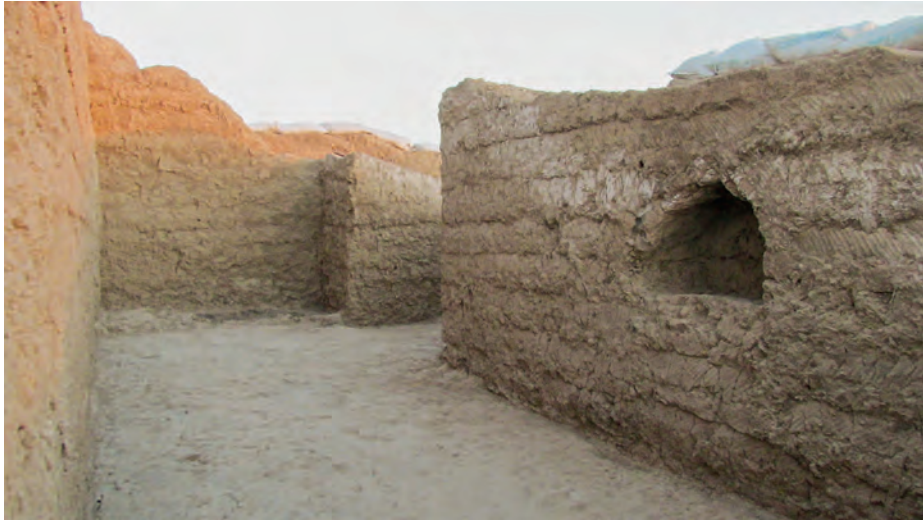
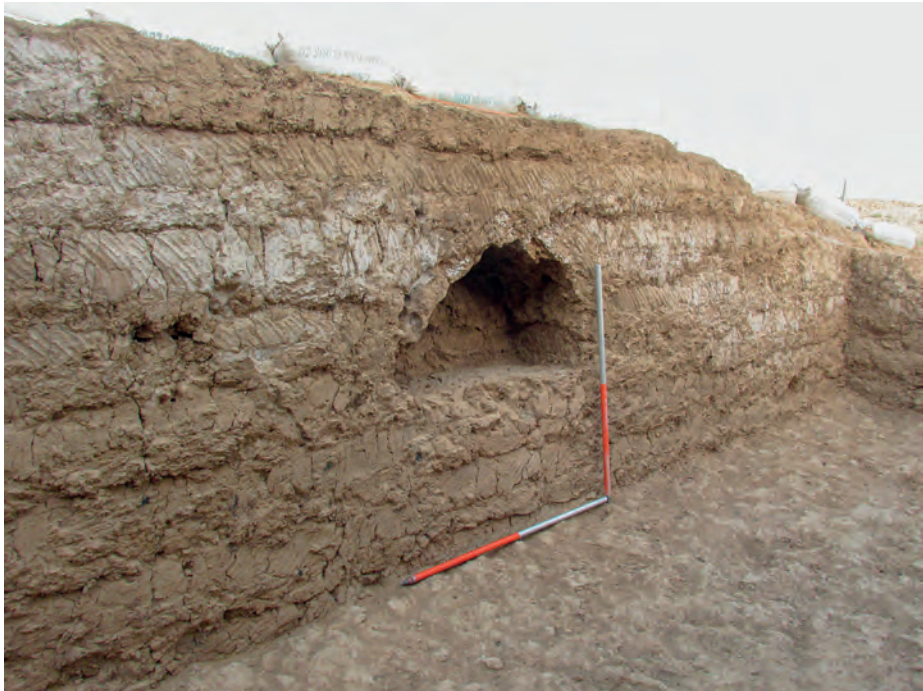
Fig. 47. Room 3 looking south showing the entrance to the west bay and the niche in the northern part of the west wall.

Fig. 48. Niche in the west wall of Room 3.

A single large pointed triangular arch-shaped niche was located on the west wall (Figs. 47-48). It measured 90 cm wide, 55 cm high, and 40 cm deep. Like the middle niche in the east wall of Room 1, it was 85 cm above the floor. No niches were found in the east wall. Ventilation holes were not observed in the north wall or in the west wall of the west bay.

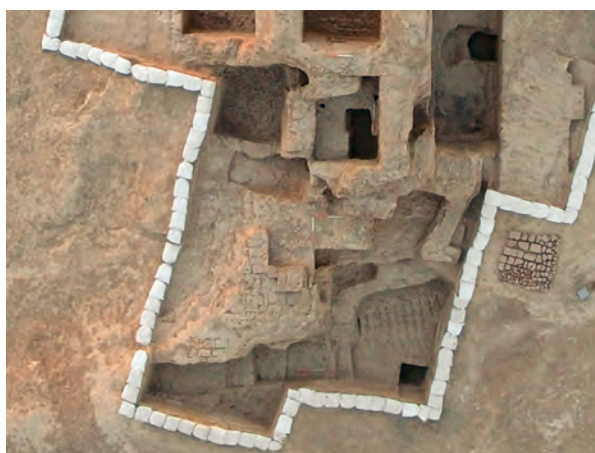
Fig. 49. Air view of the southern part of the excavated area.

The excavation of Rooms 4, 5, and 6 was complicated by disturbances done to the site by earlier robber trenches and more recent destruction by bulldozers and other earth moving machinery (Fig. 49). It was not possible to excavate these rooms completely and there are still several unresolved questions. The excavators noted that the fill of Rooms 4, 5, and 6 was different from the fill of Rooms 1, 2, and 3, which, except where disturbed by later pits, consisted of broken brick and earth presumably from the collapse of the walls and roof. By contrast the fill of Rooms 4, 5, and 6 included articulated brickwork and not just fragments of fallen mud-brick. This was interpreted as an intentional filling with mud-bricks like that found extensively at Tepe Nush-i Jan. Further analysis, however, suggests that this brickwork is evidence for the existence of a second storey.

Room 5 is situated to the west of Room 4 and to the south of Rooms 2 and 3. This area was badly damaged by the mechanical diggers and by looting. A large pit may have removed the west wall and the western part of the south wall of the room (Figs. 49 and 55). The surviving lengths of the north and east walls were 2.6 m and 2.7 m respectively. If the proposed length of the east wall is correct, the south wall would have been in line with the south wall of Room 1.

The east and south walls of Room 6, which was situated south of Room 4, like the west and south walls of Room 5, were not found in the excavation. Shortly before the excavation started, earth-moving machinery took a semi-circular scoop out of the mound to the west of Room 6 and removed a considerable part of the mud-brick massif encasing the building and probably also the west wall and the western part of the south wall of Room 5. A further attack on the mound was made by a toothed digger which left the marks of its teeth in the bedrock and may have removed the east wall of Room 6 (Fig. 49).

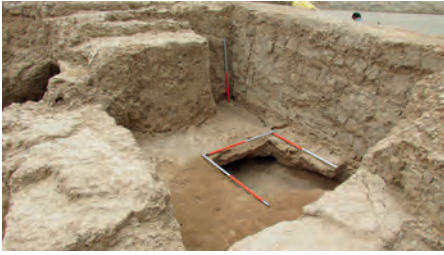
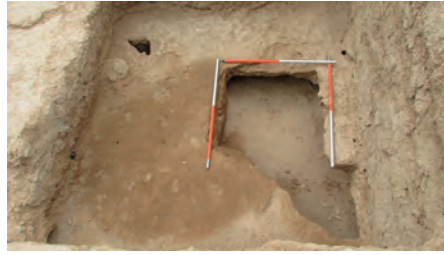
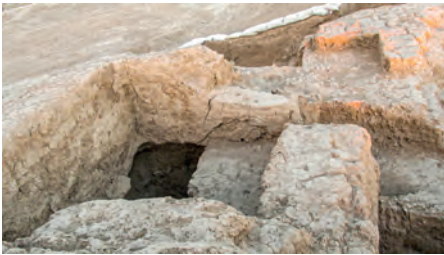
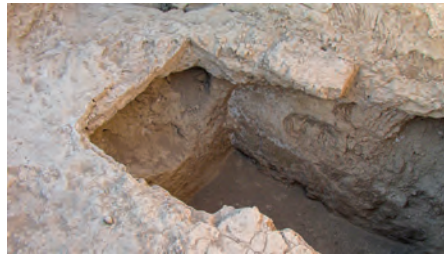
Fig. 51. View over Room 4 from the south-west. The measuring rods are resting on the upper floor.

Fig. 52. The upper floor in Room 4. Note the empty space beneath the floor.

Fig. 53. View over Room 4 from the north.

Fig. 54. Room 4, showing the east wall of Room 4 below the high level floor.

At a high level (about 2.7 m above the floor levels in Rooms 1, 2, and 3), a layer of mud-bricks ($45 \times 25 \times 12$ cm) was identified covering much of the room leaving an open area near the south-east corner (Figs. 51-54). It is possible that this layer originally covered the whole of the room but had been destroyed by a later pit. Since artefacts, such as pottery, animal bones, and a clay figurine of a quadruped (perhaps a sheep or a dog), were found on this layer, it was used as a floor at some date. Excavation photographs show that there was a hollow space beneath this floor suggesting that the floor was still almost in its original position. The similarity of this feature to the situation of Rooms 2 and 2A in the Central Temple at Nush-i Jan is striking and it is possible that the upper floor in Haji Khan Room 4 was supported on mud-brick struts like those in Nush-i Jan. In this case it is likely that the struts ran from east to west across the narrower width of the room, since at Nush-i Jan rooms wider than 2.5 m were not roofed with mud-brick struts.

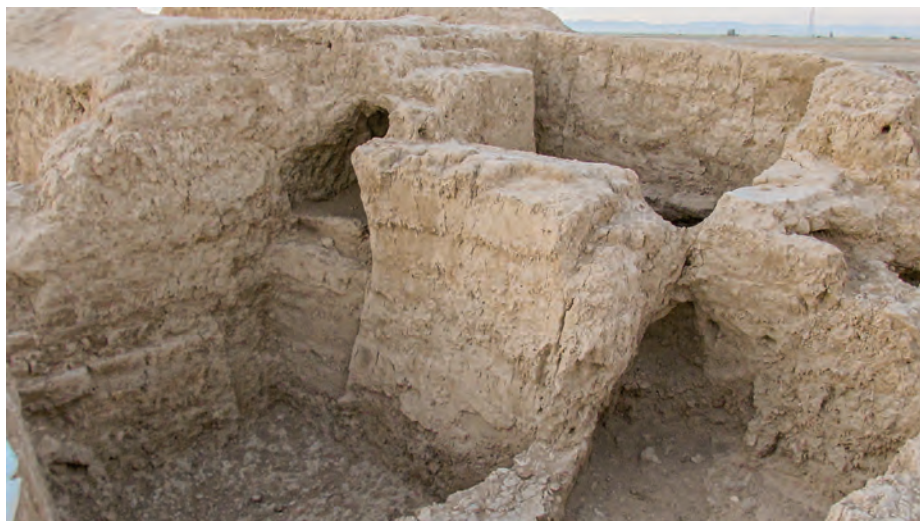
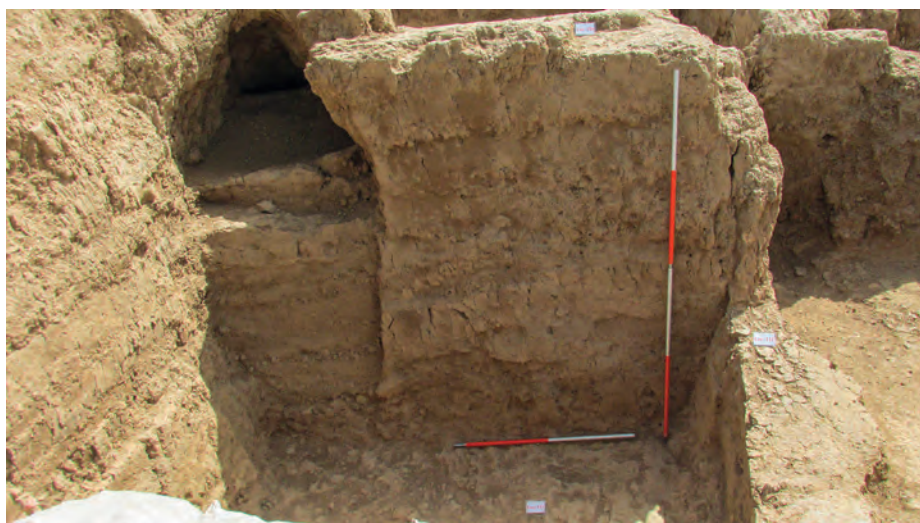
Fig. 55. Room 5 from south-west.

Fig. 56. East wall of Room 5, showing the passageway with a pointed arch.

Brickwork found within the fill of Room 5 suggested to the excavators that the room was originally filled with mud-bricks, but another explanation is more probable. Examination of photographs and comparison with the Central Temple in Nush-i Jan suggest that there was probably a spiral ramp in Room 5. This was not recognised at the time of excavation. At the north end of the east wall there appears to have been a roofed passage through the wall with roofing struts meeting at an angle creating a ceiling with a pointed arch profile (Figs. 55-56). As the upper part of this passage

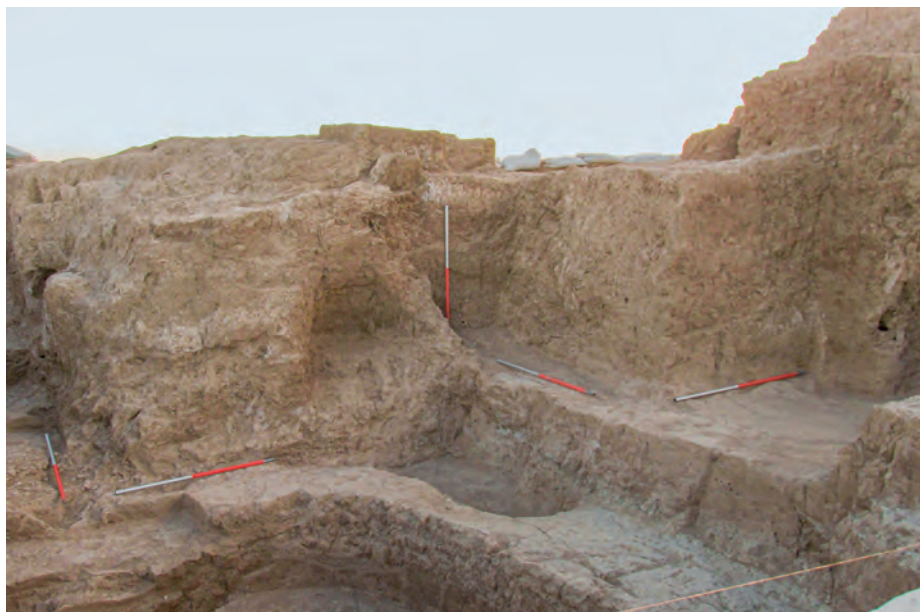
Fig. 57. West wall of Room 6.

The west wall of Room 6 (Fig. 57) was in line with or slightly to the east of the west wall of Room 4 and this side of the room was 2.50 m long: this may have included a length of a supposed wall in the mud-brick massif that surrounded the building (Fig. 57). The north-south length of the original west wall was probably c. 1.7 m as the excavators identified a difference between this wall and the mud-bricks surrounding the building at this point. The width of this wall would then have been c. 1.6 m.

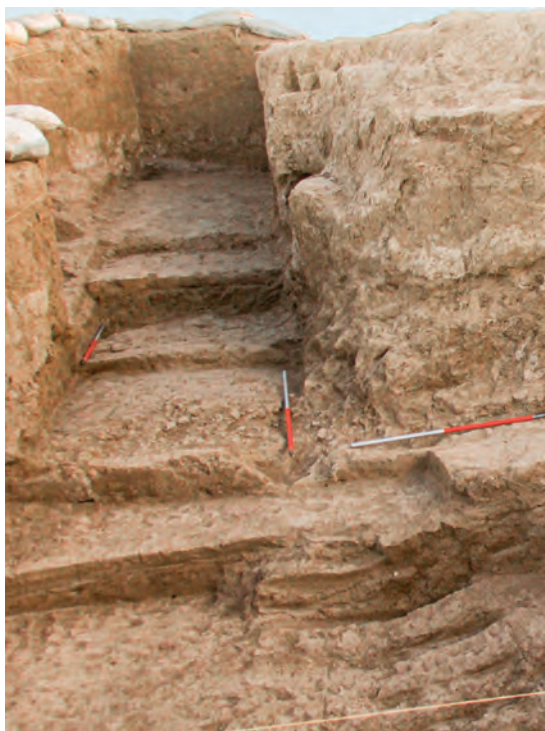
Fig. 58. View of Corridor 7.

Within the mud-brick encasing the building was a passageway (Corridor 7) running roughly from west to east (Fig. 58). The floor of this corridor was made of an olive-green clay. It was 1.3 m wide and extended some 6.9 m sloping down to the east. Near the east end there were four steps going down before it turned through 90° towards the north for a further 3.5 m leading to Room 6, the presumed entrance to the temple (Fig. 59). It therefore appears that, when the brickwork encasing the temple was built, it was necessary to preserve a means of access into the building⁸.

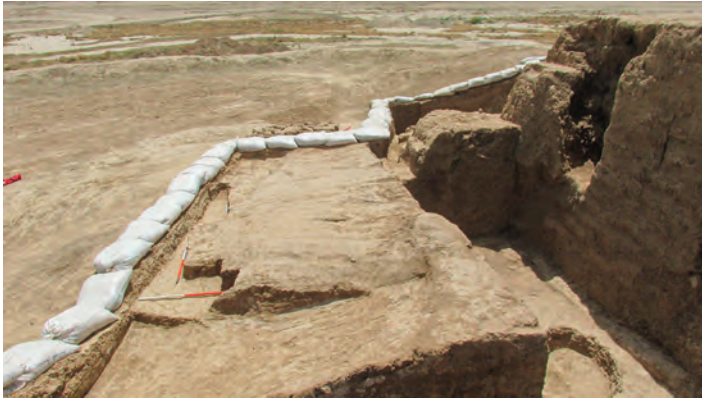
Fig. 60. The area east of the southern part of Room 1 looking south. Note the buttress next to the measuring rods.

In two places, buttresses on the external wall of the temple could be recognised. To the east of the southern part of Room 1, a rectangular buttress, a recess, and part of a second buttress were identified (Figs. 60-62). The buttress was c. 1.2 m wide and c. 0.5 m deep.

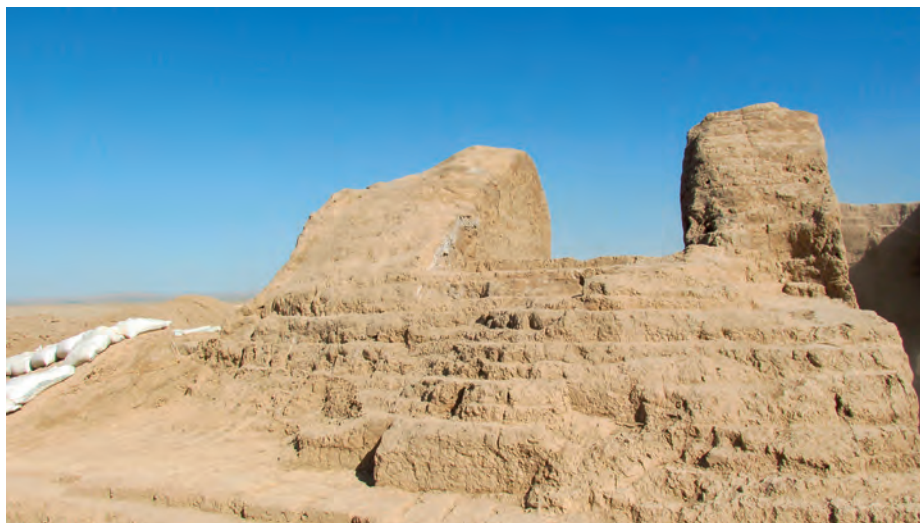
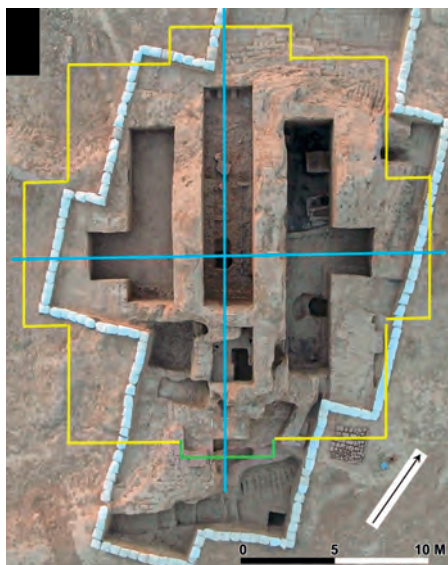
Fig. 63. The area north of Room 1 from the north. Note a possible buttress on the outer wall of the temple in the middle foreground.

Fig. 64. An air view of the temple with a possible outline of the outer wall. This line marks the external part of the wall and does not include the positions of buttresses and recesses.

South of Room 1 there appears to be a part of a buttress and recess belonging to the external wall of the temple (Fig. 63). The width of the outer wall (including the buttress) at these points was about 2.9 m. Assuming that the outer wall was of uniform width on the west, north, and east sides and the plan exhibited a considerable degree of symmetry, it is possible to reconstruct the outline of the external walls on the west, north, and east sides, and the outline of the south-west and south-east corners of the building (Fig. 64).

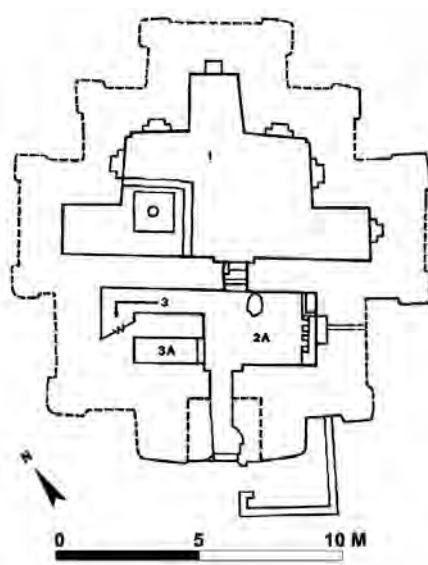
Fig. 65. The plan of the Central Temple at Tepe Nush-i Jan.

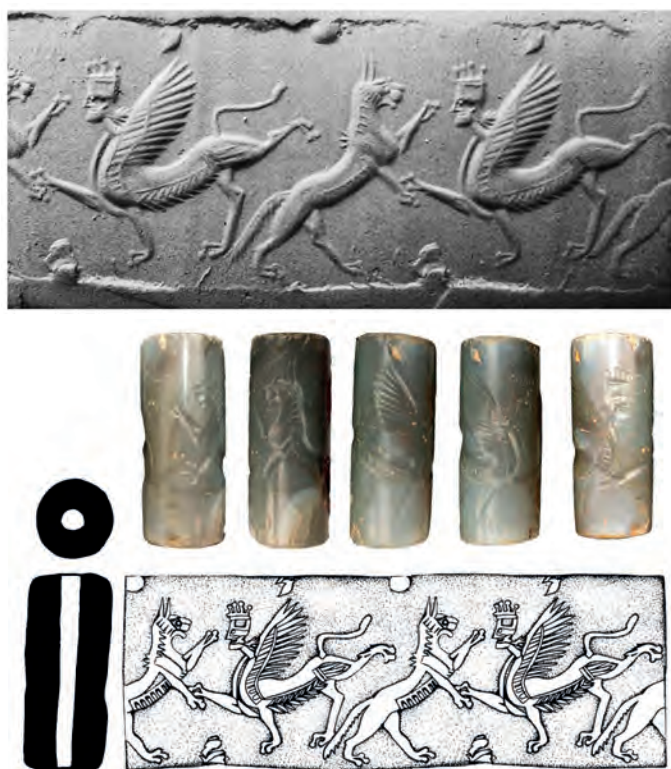
Fig. 67. The cylinder seal from Haji Khan Tappeh.

One of the most valuable finds from the Haji Khan Temple is a blue grey stone cylinder seal (Fig. 67). It was found during the final days of the excavations in one of the looters' pits in the vicinity of Room 6. This seal is 4.2 cm high and 1.7 cm in diameter, with a 0.4 cm diameter vertical perforation. The image shows a human-headed winged lion with a special crown with four projecting vertical lines topped with drilled circles fighting a lion standing on its rear legs while raising its front legs. It is skilfully carved. Stylistically it is in a style typical of the reign of the Middle Assyrian king Tukulti-Ninurta 1 (1243-1207 BC) (Matthews 1990: 103). It is therefore an heirloom from a much earlier period. It is tempting to suggest that this valuable object came into the possession of the Medes when they sacked the Assyrian cities at the end of the seventh century BC, but there is no way of confirming this hypothesis.

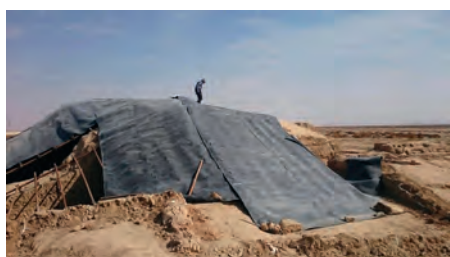
Fig. 68. Conservation under way at Haji Khan Tappeh.

After the excavation season ended, measures were undertaken to preserve the site (Figs. 68-69). The whole of the temple was covered with tarpaulins and then with polythene sheeting. It is to be hoped that in the future it will be possible to erect a roof over the temple and allow tourists and scholars
